## QUALITY TEST CERTIFICATE

Test report No. 10995.03 / 14

Certification of the degrees of protection IP54 with overpressure for the **incremental encoder HOGS151 DN 5000** under defined environmental conditions, according to the specifications of the standards and to the demands of the client.

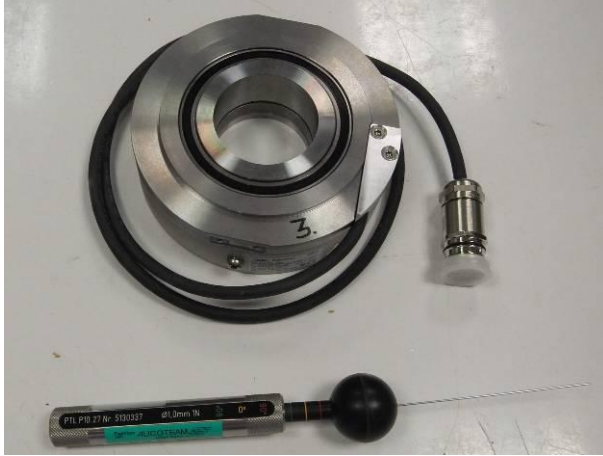
**Picture 1**  
Incremental encoder HOGS151 DN 5000  
with standardized test wire (Ø 1 mm, 1 N)  
before the access to hazardous parts test IP6X

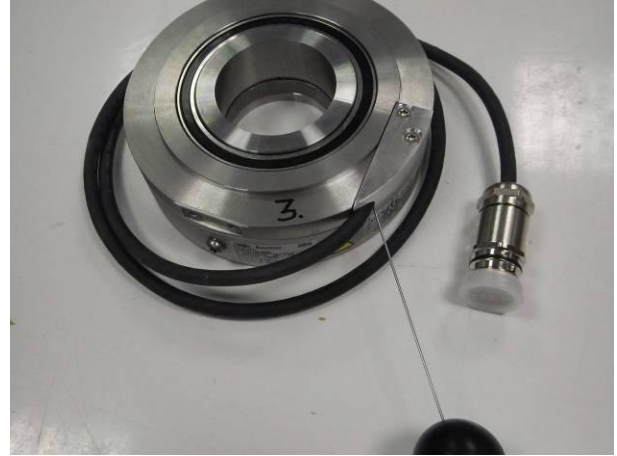
- The test wire could not penetrate the housing.
- No external damage or any other alterations
- No traces of dust was inside the specimen.

**Picture 2**  
Incremental encoder HOGS151 DN 5000  
with standardized test wire (Ø 1 mm, 1 N)  
during the access to hazardous parts test IP6X

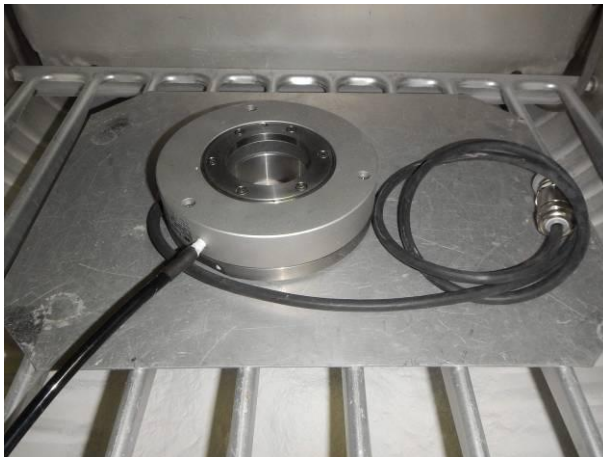
**Picture 3**  
Incremental encoder HOGS151 DN 5000 in the  
dust chamber SK 160 with overpressure hose  
before the dust test IP6X

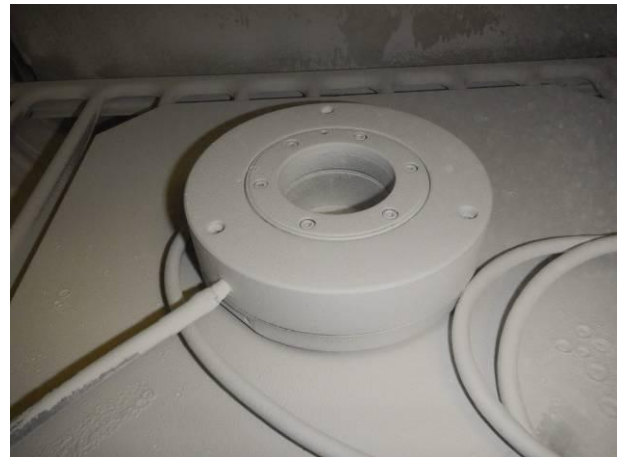
**Picture 4**  
Incremental encoder HOGS151 DN 5000 in the  
in the dust chamber SK 160 with overpressure hose  
after the dust test IP6X

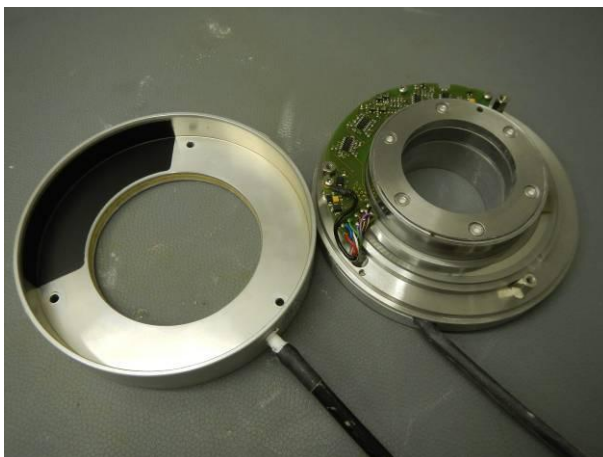
**Picture 5**  
Incremental encoder HOGS151 DN 5000  
without visible traces of dust inside  
after the dust test IP6X

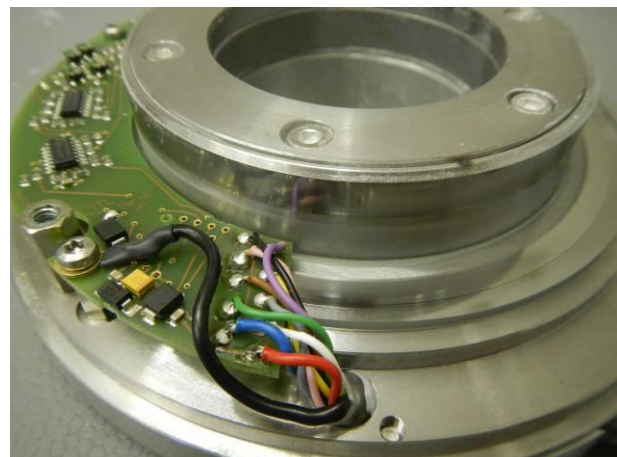
**Picture 6**  
Incremental encoder HOGS151 DN 5000  
without visible traces of dust inside  
after the dust test IP6X

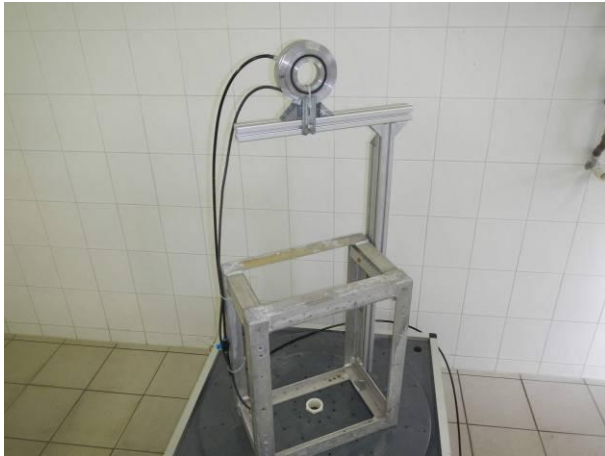
**Picture 7**  
Incremental encoder HOGS151 DN 5000  
mounted on the turn table  
*before the protection against splash water test IPX4*

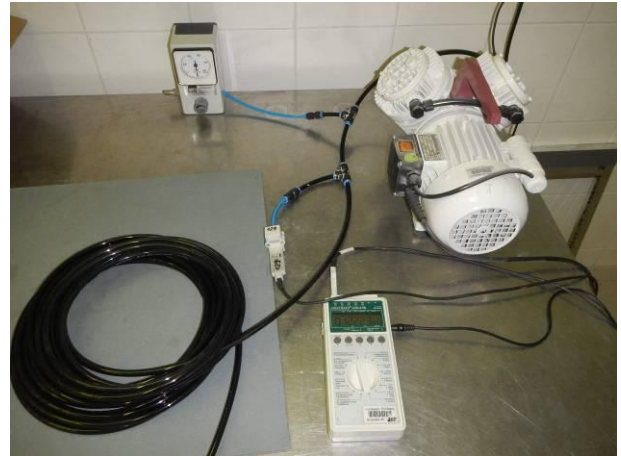
**Picture 8**  
Incremental encoder HOGS151 DN 5000  
with equipment for overpressure regulation  
*before the protection against splash water test IPX4*

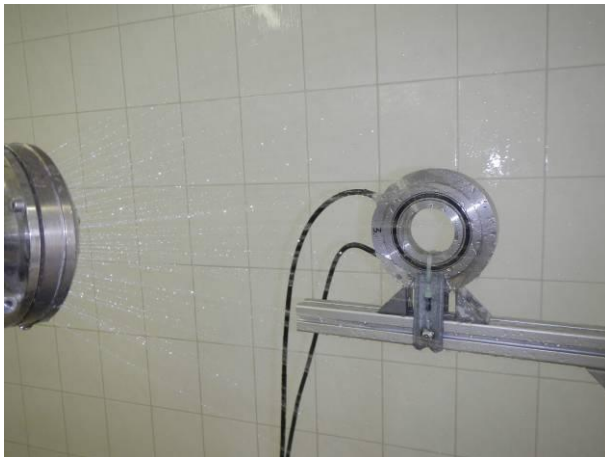
**Picture 9**  
Incremental encoder HOGS151 DN 5000  
with standardized splash water  
*during the protection against splash water test IPX4*

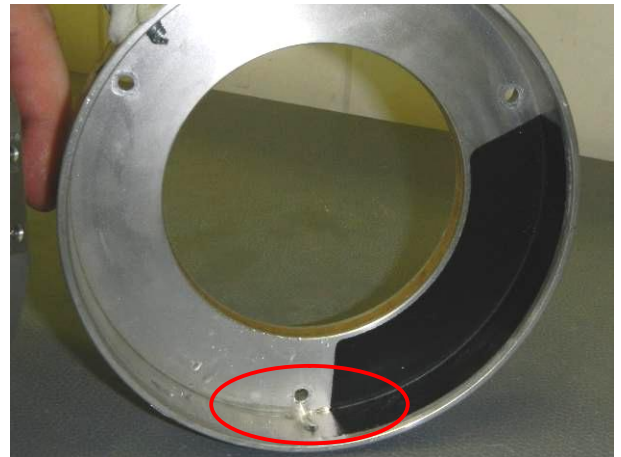
- Without external damage or any other alterations.
- Traces of water were detected inside the housing of the specimen.
- Circuit board without traces of water.
- The client estimates the determined water inside the housing as non-critical.  
The degrees of protection IP54 was proven.

**Picture 10**  
Incremental encoder HOGS151 DN 5000  
with visible traces of water inside the housing  
*after the protection against splash water test IPX4*

Further evaluation will be done by the client.

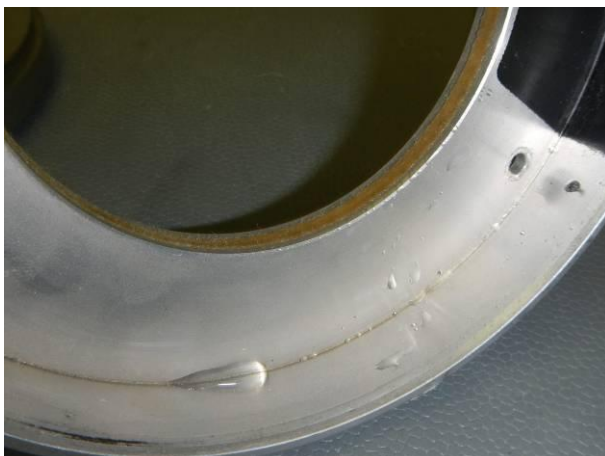
**Picture 11**  
Incremental encoder HOGS151 DN 5000  
with visible traces of water inside the housing  
*after the protection against splash water test IPX4*

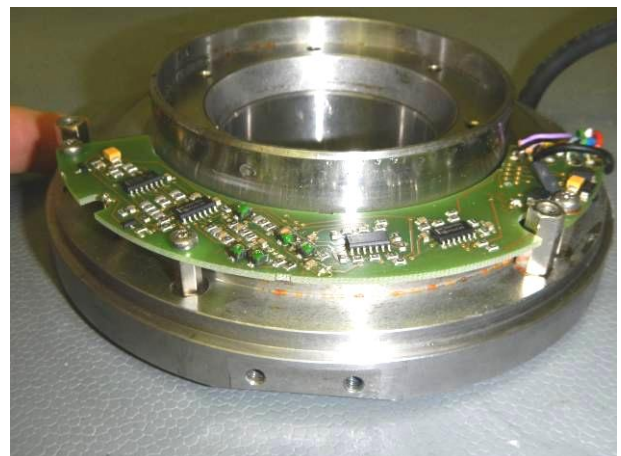
**Picture 12**  
Incremental encoder HOGS151 DN 5000  
without visible traces of water on the circuit board  
*after the protection against splash water test IPX4*
